Analysis of Flood Damage Assessment through WorldView-2, Quick Bird and Multispectral Satellite Imagery in Southern Punjab, Pakistan

Abstract. Pakistan has faced numerous natural disasters like floods, earthquakes, landslides and environmental degradation which severely affects the Pakistan's economy and results in various problems like causalities, diseases, water stress and severe damages (e.g., houses, public infrastructure and agricultural land erosion). There is a lack of systematic approaches to analyze pre and post damage assessment for estimation of exact loses and the total cost for rehabilitation of damaged infrastructure in an efficient way. There exist a variety of mechanisms but GIS based flood mapping is considered the most efficient to manage the flood situation. This study is focused on evaluation of flood affected areas especially in Punjab using WorldView-2, 8-band multi-spectral imagery by applying Remote Sensing (RS) and GIS techniques. The research area is comprised of Kot Addu and Muzaffargarh Districts in Punjab province of Pakistan that faced a catastrophic super flood of 2010. The WorldView-2, Quick Bird and multispectral satellite imagery are capable of m

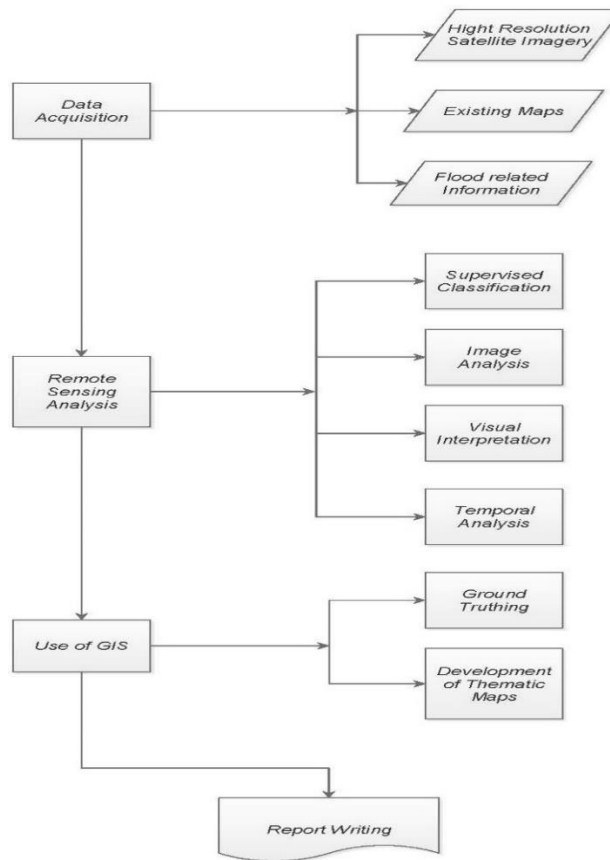
Figure 3: An Overview of the Methodology

The data was provided by the Digital Globe in patches. The mosaicking process was performed in Erdas Imagine to form a single scene of the WorldView-2 imageries. Moreover, the panchromatic image was diffused with multispectral imagery to get more clarity and high quality for visual interpretation. To identify the damaged features, visual interpretation technique is performed by using FCC on the multispectral 8-band imagery of spatial resolution 1.86m and compare with WorldView-2 panchromatic imagery of spatial resolution 0.46m, Quick Bird scenes of spatial resolution 0.6m along with digital photographs. About 170 categories of different LULC were identified using supervised classification on the basis of training areas and further recoded into 13 broad categories. GPS coordinates and the digital photographs of these damaged roads, drainage network, abadies, education institutes, health units, bridges, different kinds of agricultural and water areas were obtained during the field survey for verification of land use classification. The methodology flow chart is given in figure 3. The thematic map of training/samples points with WorldView-2 multispectral imagery is shown in the form of figure 4.
