Riverbank Erosion & Consequent Land Settlement Issues: A Case of River Chenab, District Hafizabad

Original
Article

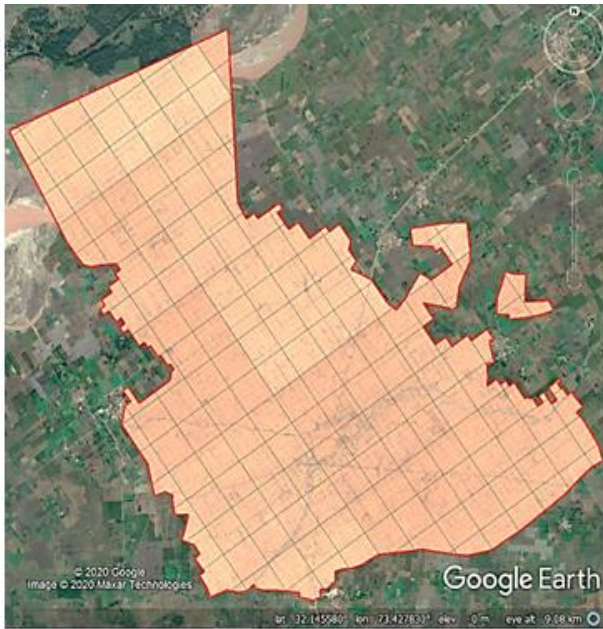
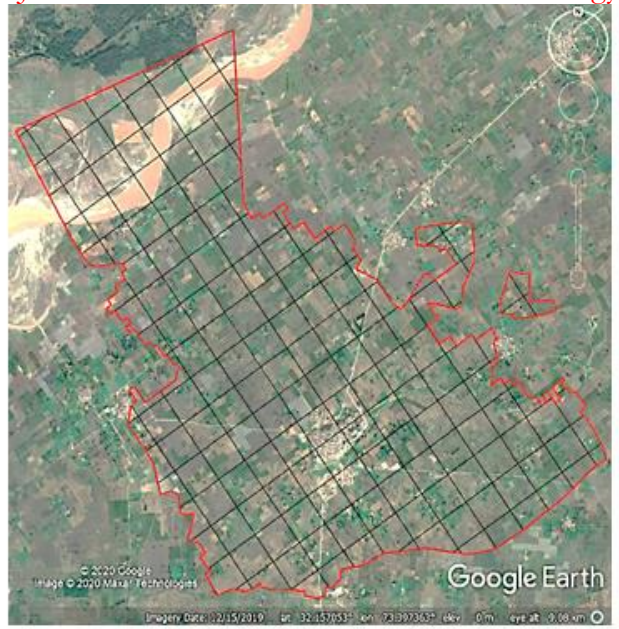
Figure 7 and Figure 8 are showing comparative pictures and ground linear features can be matched easily for evaluation as well.

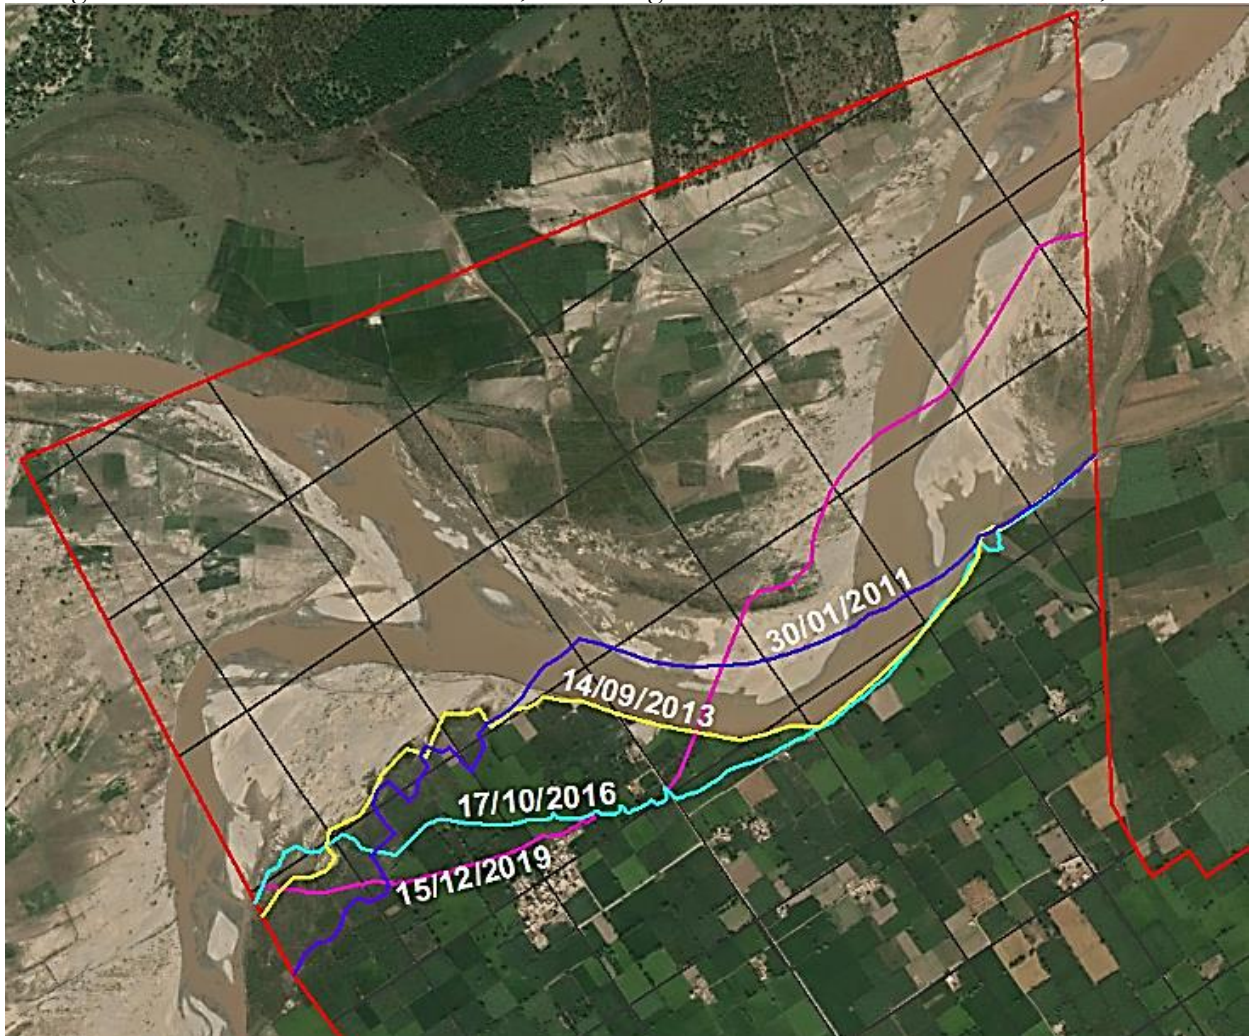
Figure 13. All time riverbank shifts' comparison

Figure 13 shows that how the riverbank is eroding land with time, it also shows that riverbank displacement from 2013-16 is more than any other span which reflects the effect of

2014’s super flood faced during this period. The joining points of riverbank displacement lines between 2013-16 and 2016-19 show 448m and 162m shift in South-West along with the river flow, respectively. This shows that the average riverbank displacement due to erosion phenomenon at this location was 12.1m/month and 4.4m/month during 2013-16 and 2016-19, respectively. The victims face economic, social and health insecurities and make families’ life more vulnerable [20], however, regular monitoring of riverbank erosion values and soil degradation can help to foresee the situation [21]. Families settled along the riverbank used to face many problems in their daily life due to issues like frequent floods and riverbank erosion [22]. On the other hand, bad governance also acts as a catalyst for the miseries of the affected community [23]. Therefore, it is needed to monitor the erosion phenomenon on regular basis to save the vulnerable communities otherwise it may turn to serious consequences as well [24]. Many remedial measures may be taken including concretization, plantation, desilting, use of nut-fibers and synthetic erosion-resistant mats [25]. Soil can be divided into different types based on erosion rate and accordingly plantation plans can be suggested, like land with heavy grade erosion can be planted by sugarcane and with low grade erosion can be corn or rice [26].

A complete comparison of all time riverbank shifts has (separately shown above in Figure 9, 10, 11 & 12) displayed in Figure 13 below:

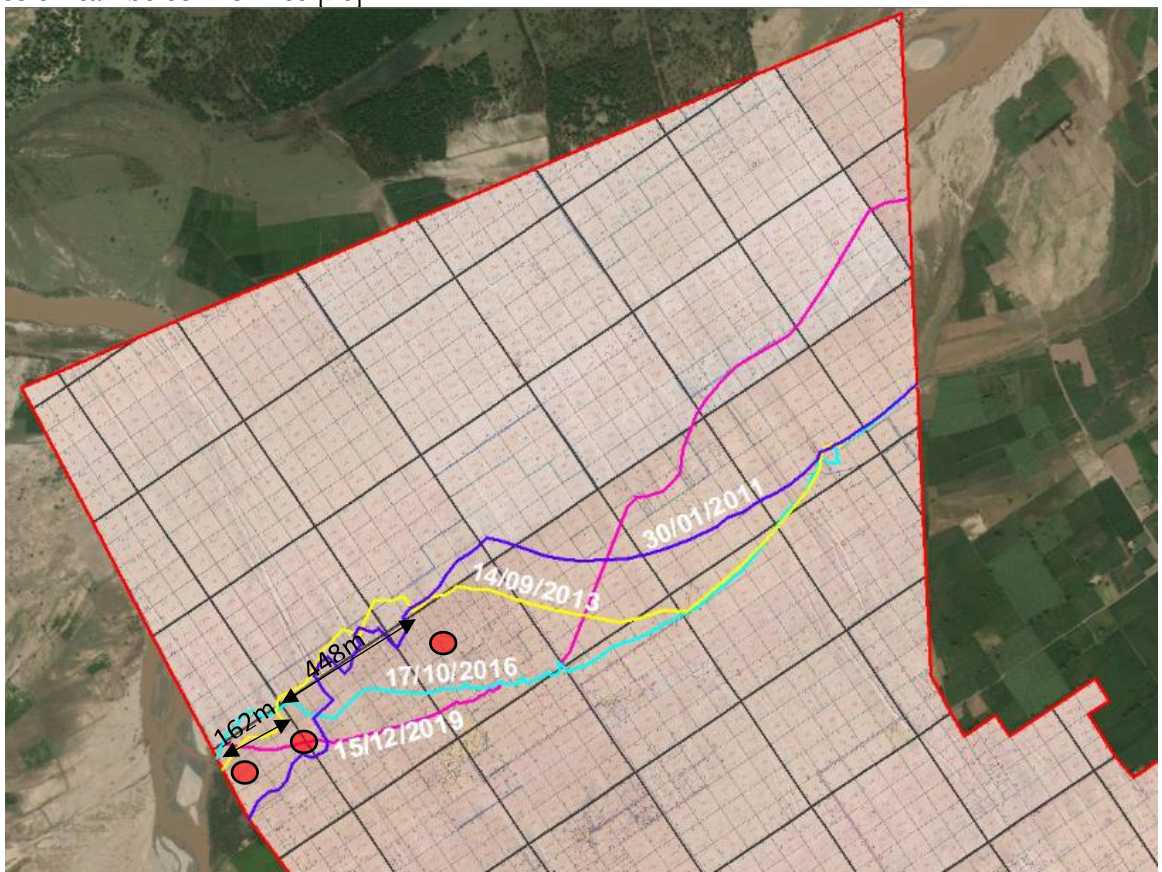
Figure 14. All-time riverbank shifts along with Massavi map (revenue record-keeping document)

The implementation of modern techniques (like RS and GIS) is not only greatly helps to study the riverbank erosion phenomenon but also be very precise to accurately identify the affected landowners. Figure 14 is self-explanatory to identify such ownerships as geo-referenced revenue land record has shown with the time-to-time riverbank displacement extents which geo-tags all the affected ownerships very precisely. This study at work has multiple benefits in the larger disaster management realm, but more specifically it is highly useful in:
